PHOTOS OF STRUCTURAL INSPECTION OF THE GALERA POINT LIGHTHOUSE

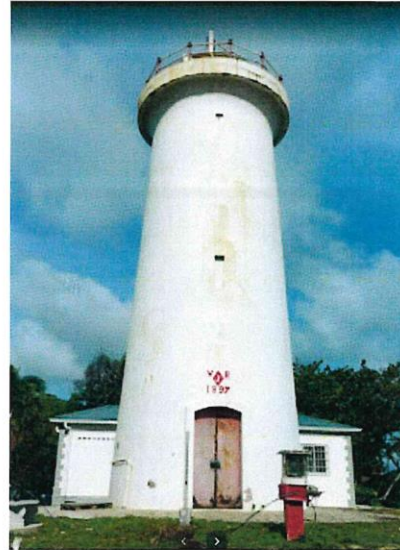
Pic. 2 Western view of the lighthouse

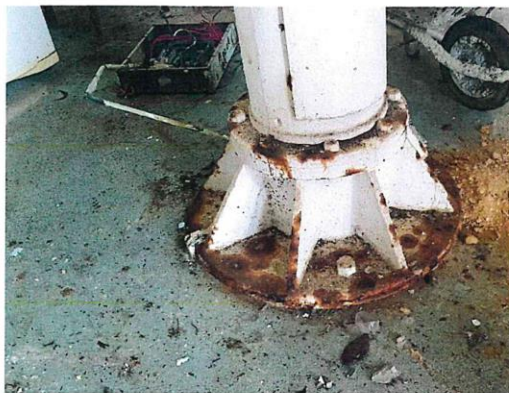
Pic. 3 Vertical pipe bolted to ground floor slab

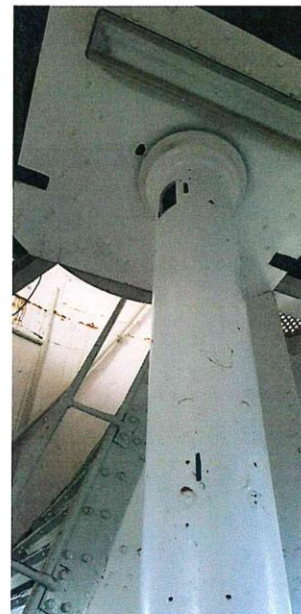
Pic. 4a. Top of vertical pipe connected to the soffit of the 3rd floor

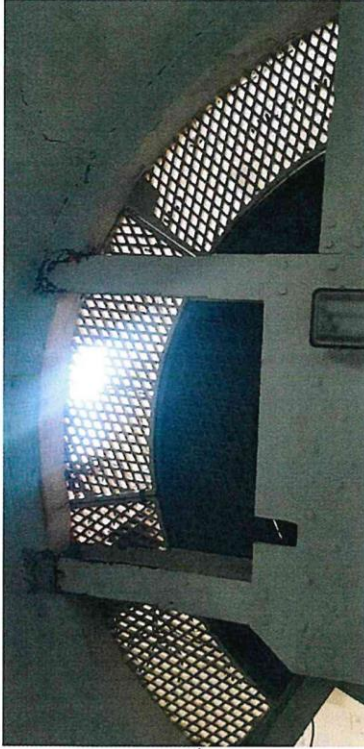
Pic. 4b. Third (3rd) floor framing

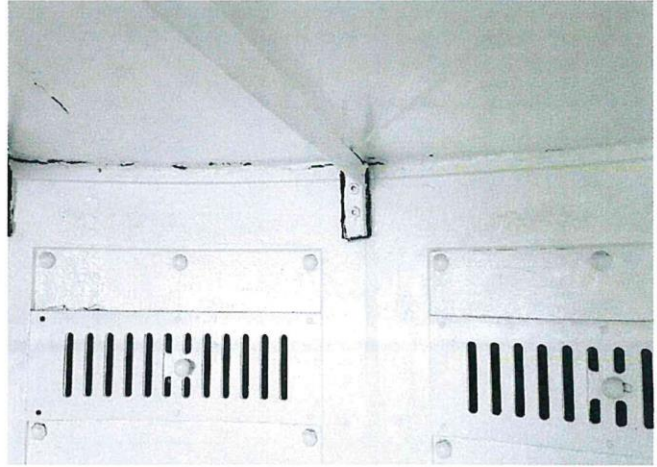
Pic. 5 Steel plate walls supporting the roof slab

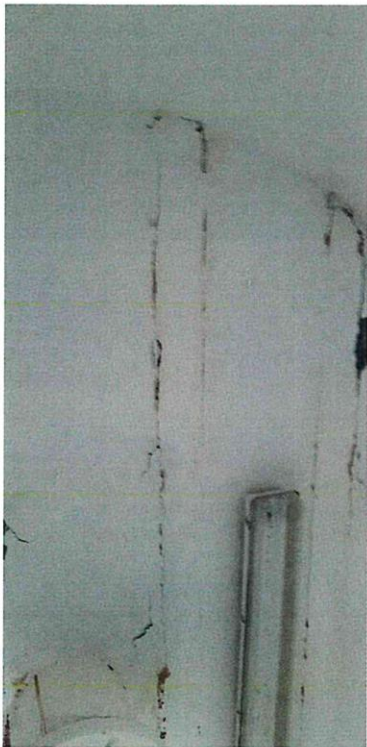
Pic. 6. Soffit of 1st and 2nd floor slabs.

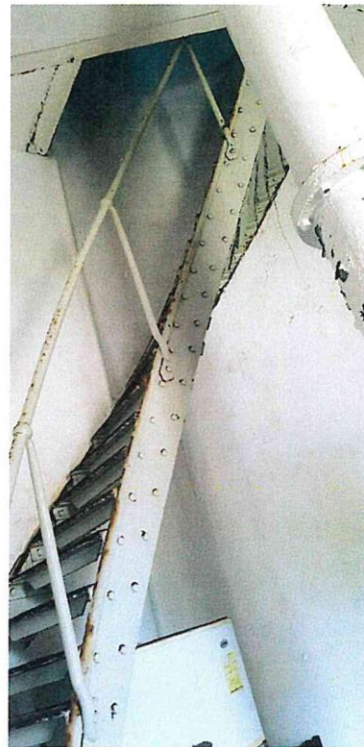
Pic. 7 Ladder from ground to 1st floor

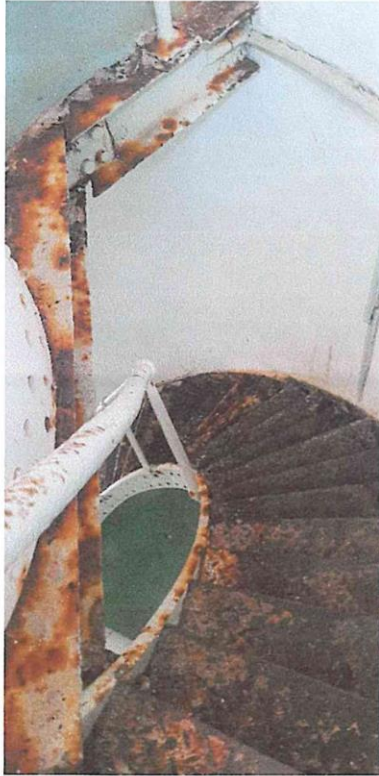
Pic 8. Ladder from 1st floor to 2nd floor.

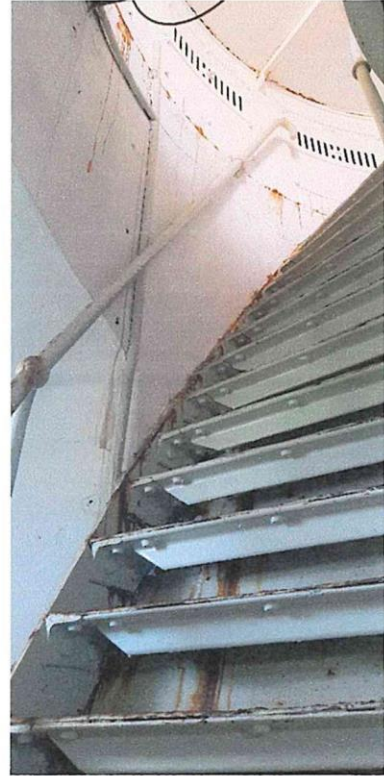
Pic. 9 Ladder from 2nd floor to 3rd floor.

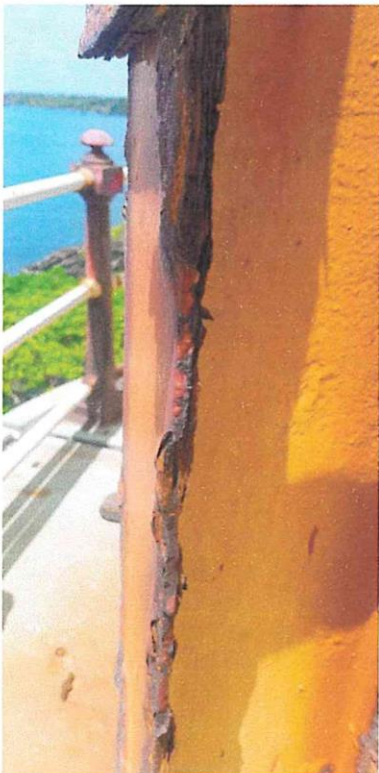
Pic. 10 Cantilever slab and corrosion of steel member

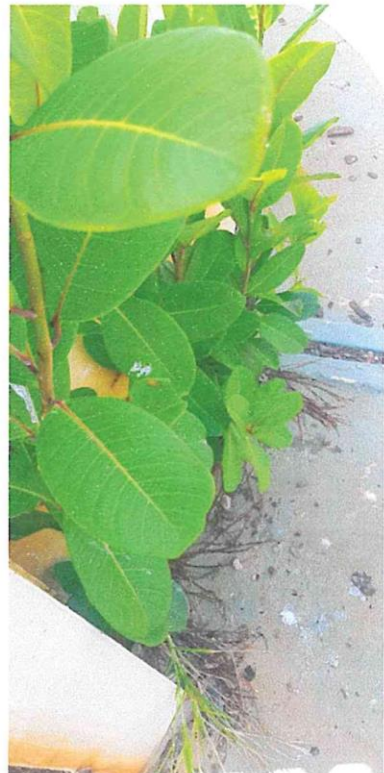
Pic. 11 Trees growing on the cantilever

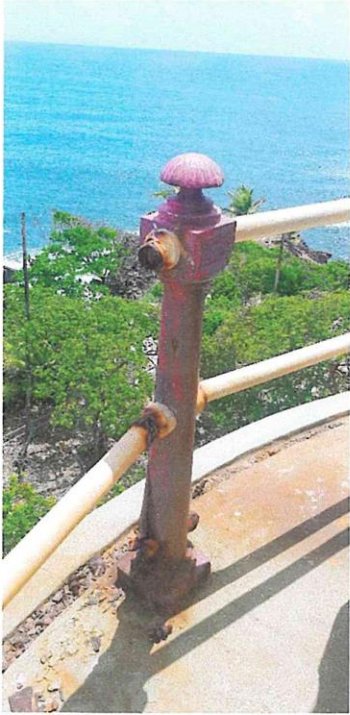
Pic. 12 Corrosion of the metal hand rails of the cantilever

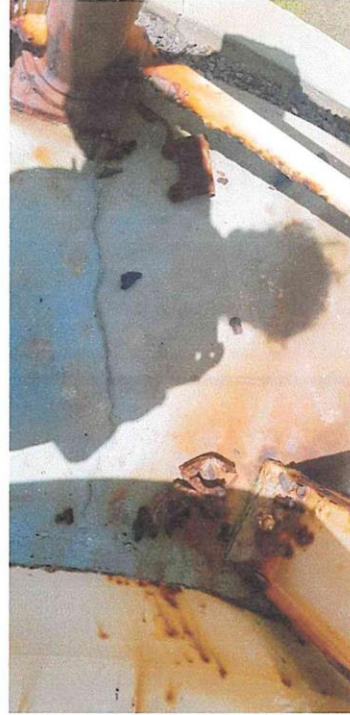
Pic. 13 Crack in the cantilever slab

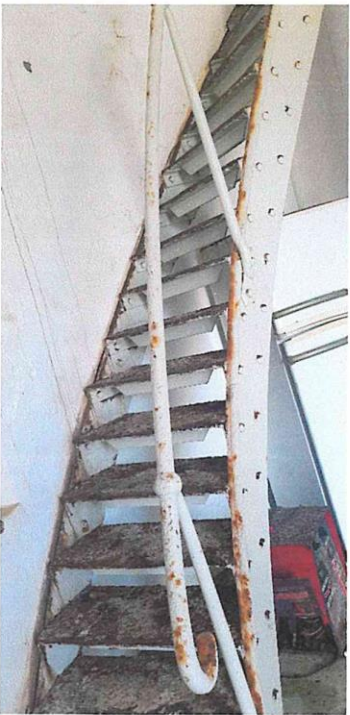
Pic. 14 Corrosion of ground floor ladder

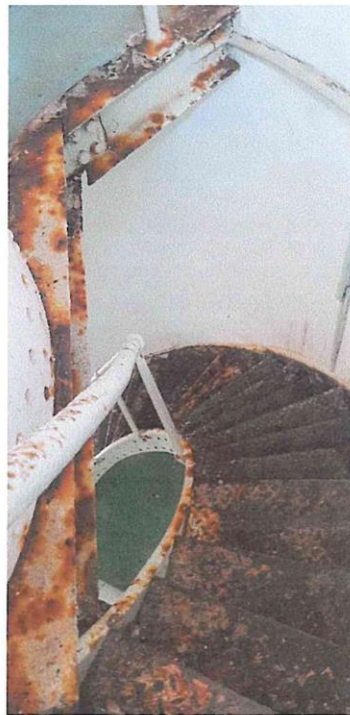
Pic. 15 Corrosion of first floor ladder

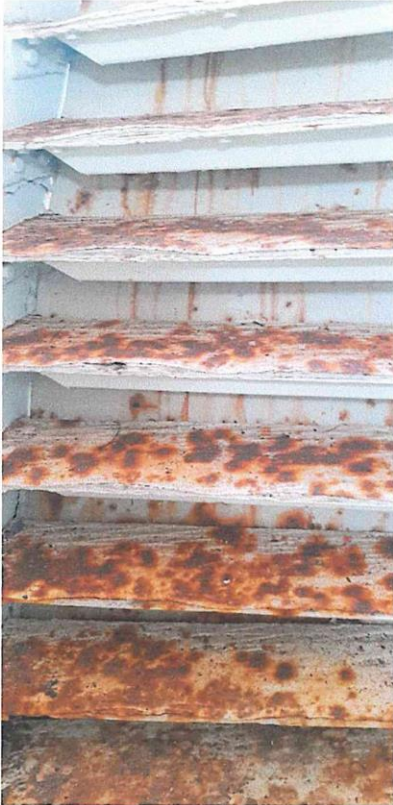
Pic. 16 Corrosion of second floor ladder

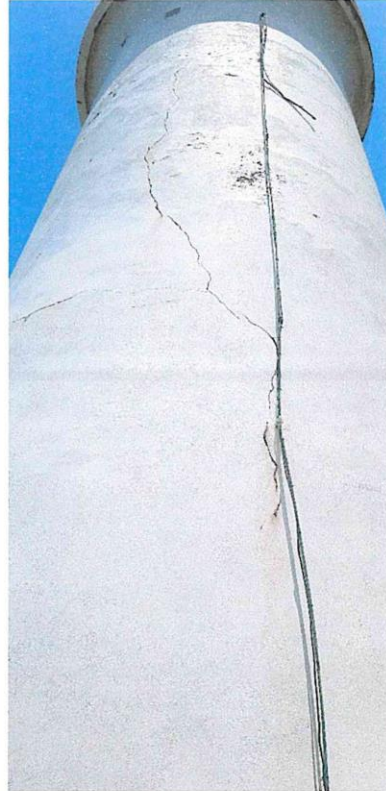
Pic. 17 Cracks of the external protective paint at the eastern face of the lighthouse

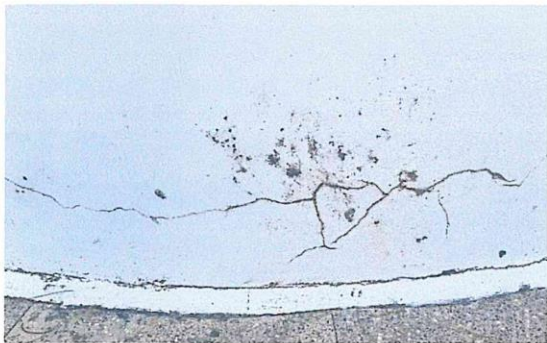
Pic. 18 Cracks of the external protective paint at the base of the eastern face of the lighthouse

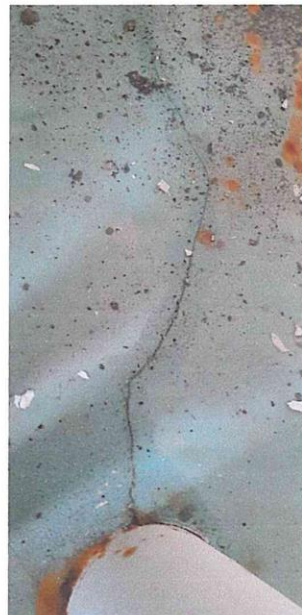
Pic. 19 Typical crack on the suspended floor slabs

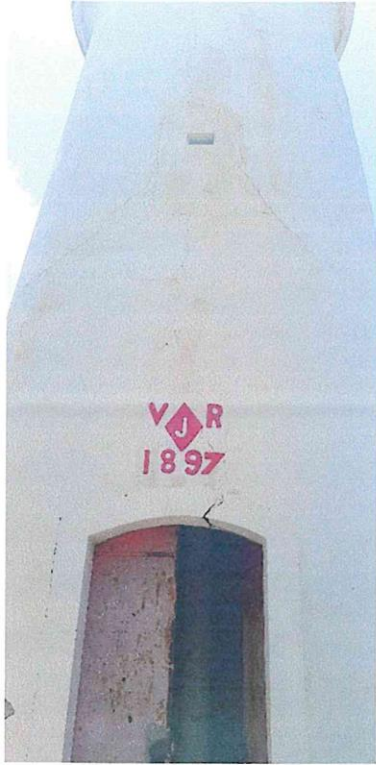
Pic. 20 Western face of lighthouse showing vertical crack

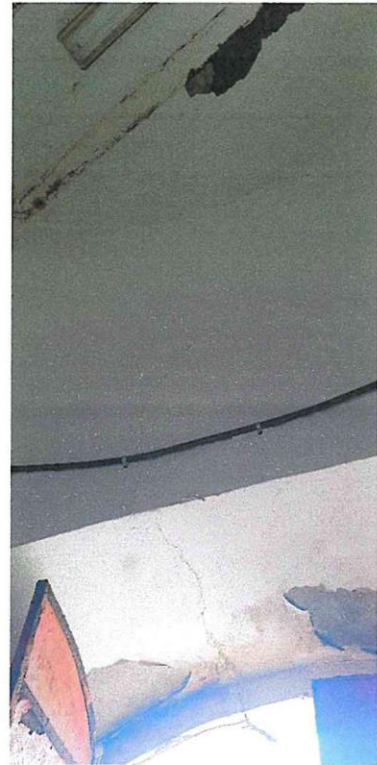
Pic. 21 Crack at soffit of doorway lintel

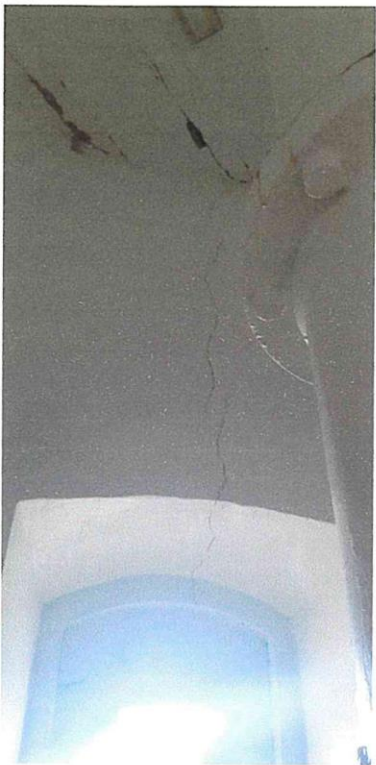
Pic. 22 Vertical crack on the lintel beam of 1st floor window propagating on the inside of the wall

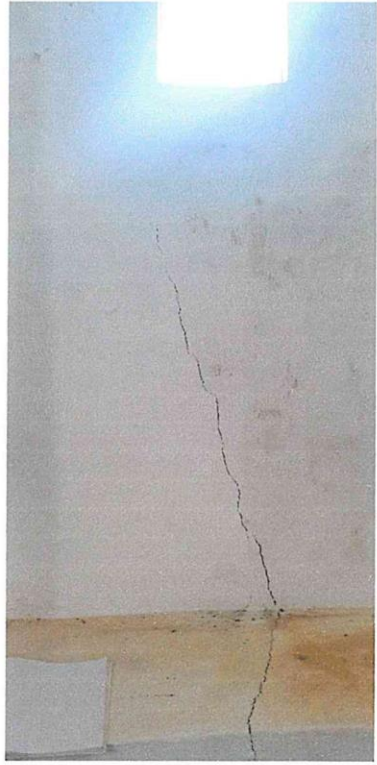
Pic. 23 Vertical crack on the inside of the wall of the 2nd floor
